GROUND
IMPROVEMENT

A Sinking Feeling in Happy Valley

Limited Mobility Grouting Arrests
Movement of Emergency Room

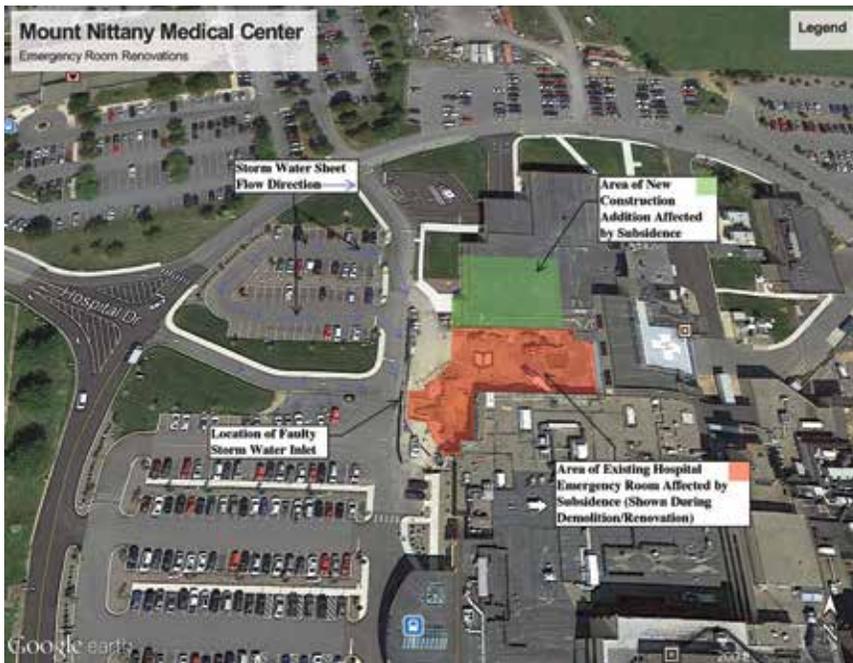
An investigation quickly focused on the stormwater management adjacent to and within the new construction zone (Figure 1). A local fire company was called to the scene, and several thousand gallons of water were poured on the upper parking lot area. The water contained a green dye to attempt to track the flow after it entered the suspect inlet, but it was quickly revealed that the inlet was not functional, and the lime green water began to flow toward the subsidence area. A test pit was excavated adjacent to one of the footings in the subsidence zone, and a classic erosion channel was revealed, indicative of the region’s challenging karst geology (Figure 2).

Figure 1. Map of Mount Nittany Medical Center, August 2012. (Image courtesy Google Earth Pro.)

The team’s first recommendation was to repair the inoperable inlet and return the site’s stormwater system to functionality. This was a critical path forward for the project, given the extremely damaging effects of concentrated water flows in this sensitive geologic environment. Sinkholes are a common occurrence in Happy Valley, and, unfortunately, they tend to show themselves during construction, when the overburden soils are most vulnerable to erosion into the soluble and cavernous limestone and dolostone bedrock formations that prevail within this region.

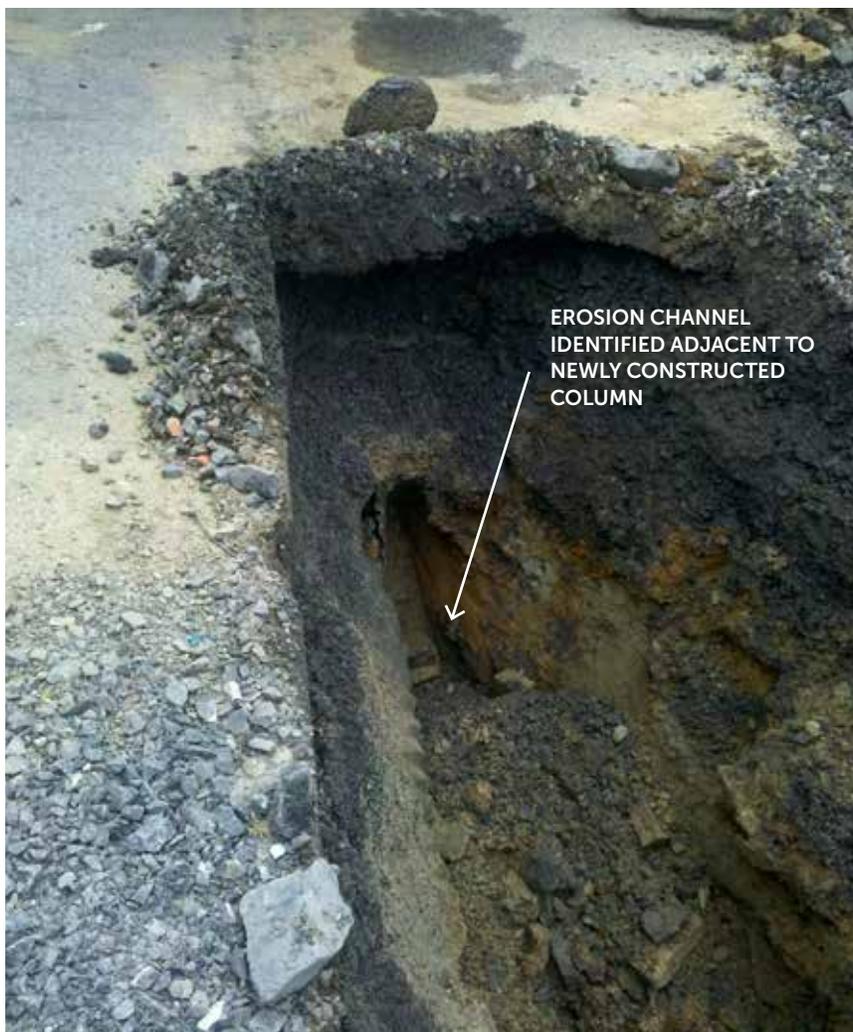
Figure 2. Test pit within subsidence zone of existing construction area. (Photo courtesy of CMT Laboratories, Inc.)

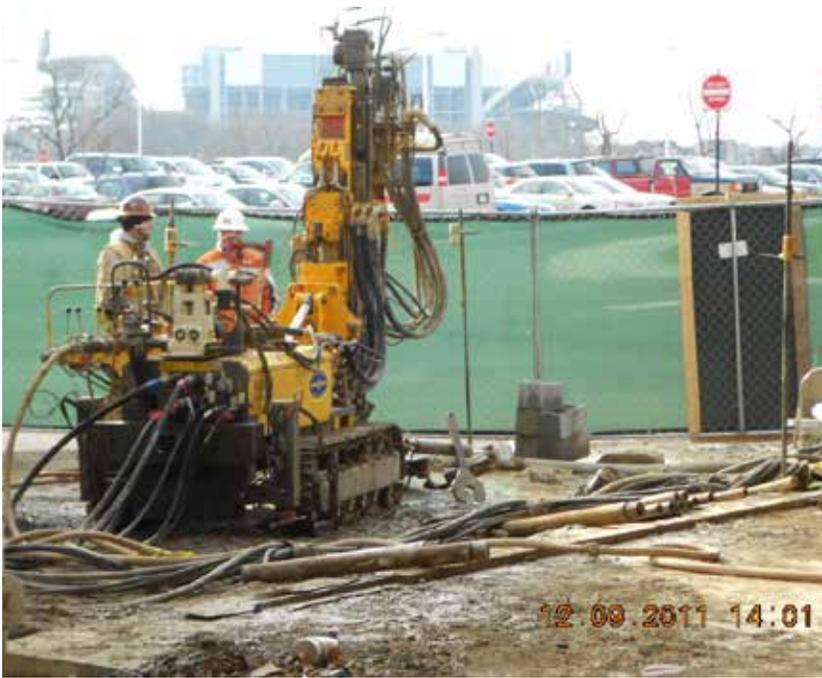
Five borings were then drilled within the new construction area. The borings revealed an extremely irregular bedrock surface profile, with the top of rock varying between 15 and 45 ft below the site within a horizontal distance of approximately 25 ft. Moisture contents in excess of the liquid limit in the residuum indicated a highly mobile condition. Split-barrel sampling produced N_{70} values consistently below 5 blows/ft within 20 ft of the bedrock surface. The quality of the dolostone of the Nittany Formation was very poor, with rock core recovery values rarely exceeding 50 percent and non-existent to single-digit Rock Quality Designation (RQD) values. Voids and soil seams were a common occurrence in the bedrock, which gives the overburden a perfect avenue of escape, should it be mobilized with excessive water migration.

Figure 3. Drill rig within subsidence zone of existing construction area with Beaver Stadium in background. (Photo courtesy of Alexander Building Construction.)

A total of 16 primary injection holes were chosen based on the test boring, geophysical, and settlement data gathered during the investigation. Duplex drilling was specified so that the casing would follow the down-the-hole hammer to prevent hole collapse in the highly unstable ground. The holes extended in depth until a minimum of 10 ft of solid bedrock was encountered, which was verified utilizing a down-hole camera. Grout refusal criteria took into account pressure (400 psi max.), heave (1/4 in. ground surface heave or any detectable movement of the structure), and grout take (100 ft³/2-ft stage). This work had to be performed in tight spaces within an existing construction zone and adjacent to an active emergency room. The contractor deployed a low-clearance specialty drill rig with adjustable tracks to allow for access to tight areas (Figure 3).

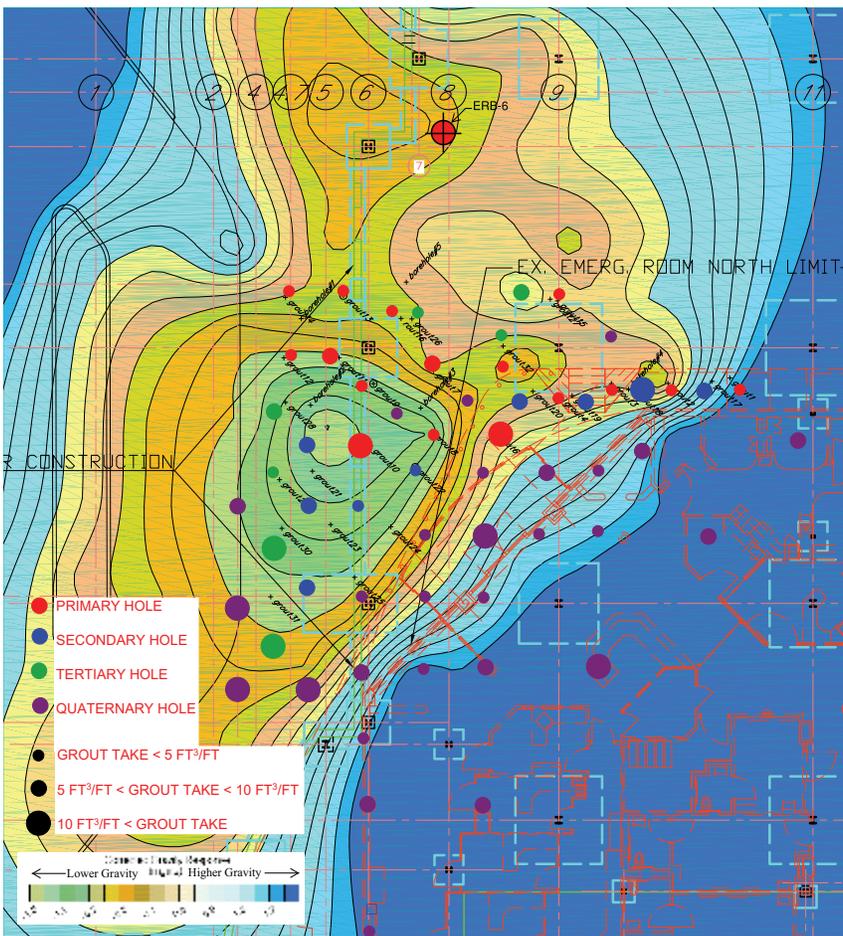
Phase I consisted of 195 differential microgravity measurements that were collected during mid-January, 2011. The results showed areas of low gravitational response, indicative of anomalies associated with voids or cavities that corresponded with the zone of greatest subsidence within the new construction area. The survey also showed an abrupt increase in gravitational response toward the existing emergency room area. These data highlighted the significant geologic differentiation typical within karst areas.

Figure 4. Microgravity contour image with grout injection data. (Image courtesy of THG Geophysics, Ltd.)

emergency room entrance. Figure 4 shows the 2-D gravitational contour mapping, along with the grout hole locations. The lowest gravitational response was recorded in the vicinity of the newly constructed column M-6, which is also the area that accepted the largest amount of grout.

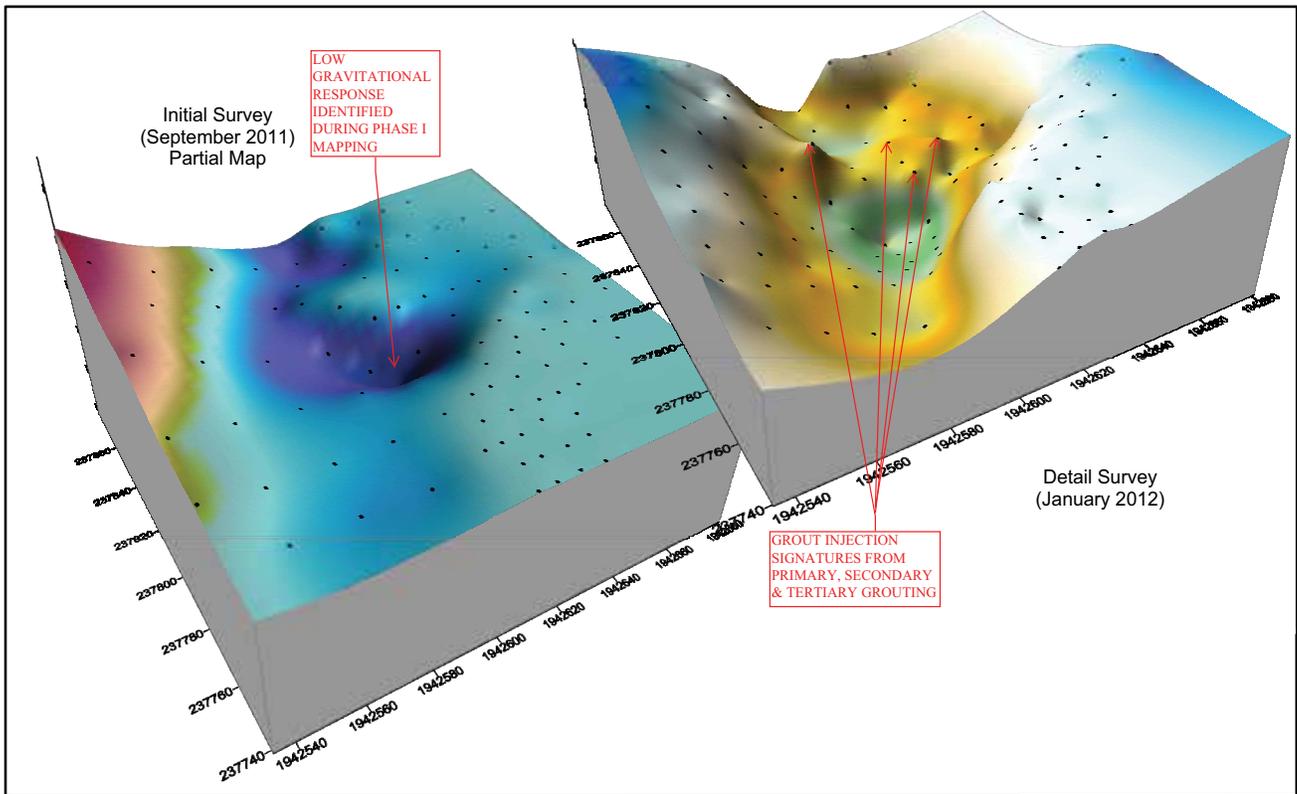
Figure 5. 3D microgravity images prior to ground improvement and following tertiary grouting phase. (Image courtesy of THG Geophysics, Ltd.)

3-D gravitational contour mapping of the Phase I and Phase II areas was also performed. Figure 5 shows the broad range 3-D mapping performed in September of 2011 and the focused mapping of January 2012. Note that the 3-D Phase II mapping was able to show the peaks associated with the grouting efforts.

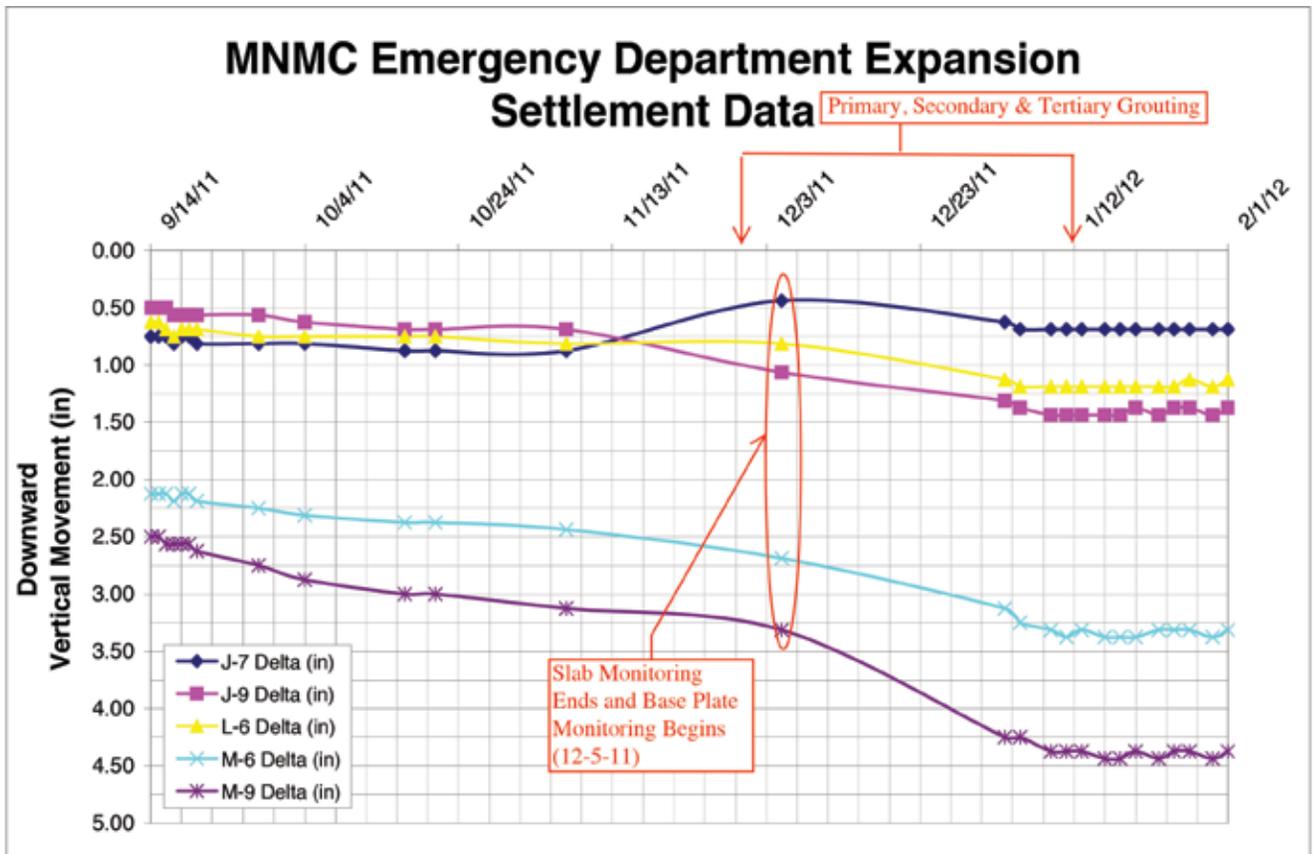
The settlement readings before and immediately after the *primary*, *secondary*, and *tertiary* grouting phases is shown on Figure 6. This information shows that the combination of the newly repaired stormwater management system and subsurface grouting operations were able to successfully arrest the movement of the structure.

Figure 6. New construction column settlement data during and after ground improvement.
